RUBBER POSTS USED AS
VEHICLE SPEED REDUCERS

Special Report Under Research Project 432
Conducted in Cooperation With
The U.S. Department of Transportation
Federal Highway Administration
Bureau of Public Roads

June 1970

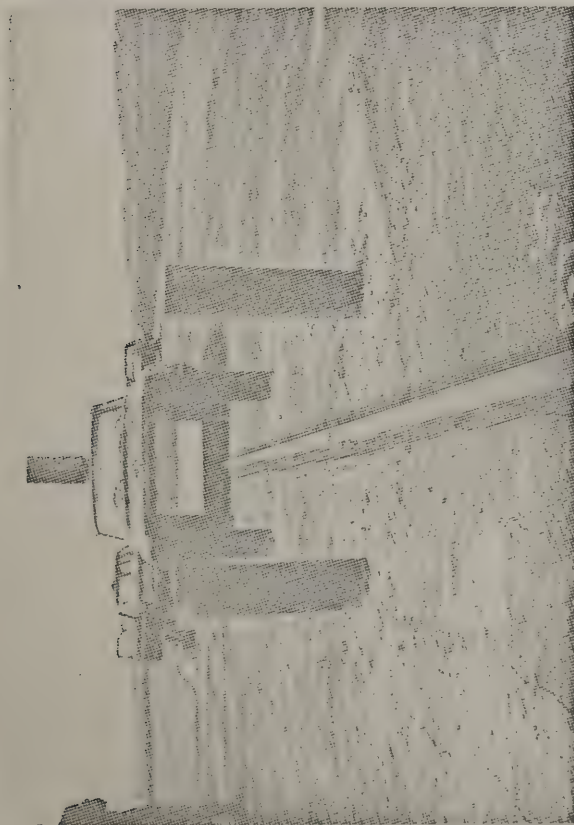
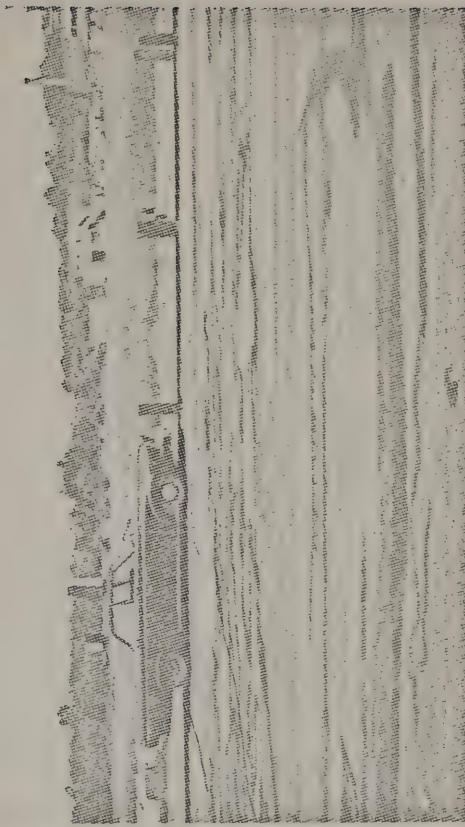
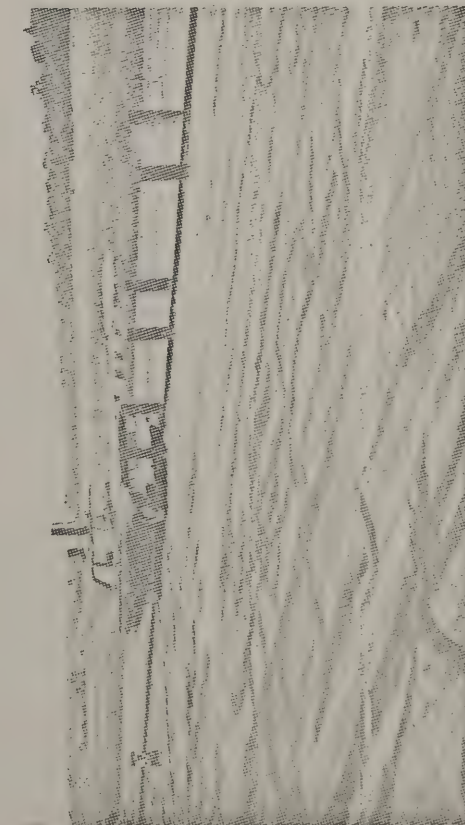
A 1963 Plymouth sedan was used as a test vehicle. Since only one vehicle was available for use in the rubber post tests, it was decided to mount a 6 x 8 inch section of box beam in place of the vehicle's front bumper. This beam section was installed to eliminate any vehicle crush which might occur, thus keeping the frontal area of the car uniform for all the tests. Photographs of the test vehicle and the rubber post array are shown in Figure 3.

Figure 3. Test vehicle and rubber post array used for Tests 87, 88, 89, and 90.

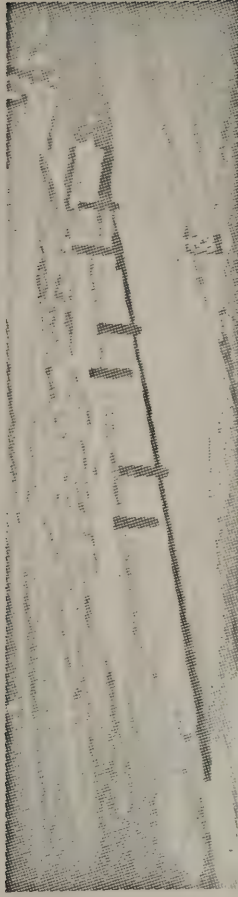
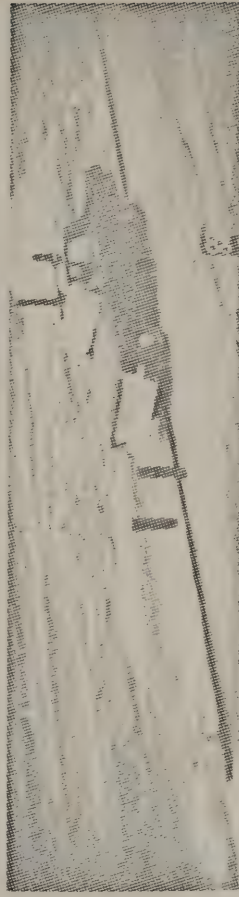
TEST 88 SUMMARY

Speed: 14.4 mph
Angle: 0° (head-on)

Speed: 0.0 mph
Angle: 0°

Length of Post-Vehicle Contact: 14.3 ft

Average Deceleration: 0.43g (1.218 sec)

Vehicle brakes were not applied during test.

Figures 12, 13, and 14 summarize the results of the three tests. Referring to these summaries, one can note that the vehicle stopped on the posts in Test 88 (14.4 mph) and Test 89 (21.0 mph). Stopping distances in these tests were 14.3 feet and 29.1 feet respectively. Average decelerations computed from these stopping distances were 13.8 ft/sec^2 (0.43 x accel. of gravity) and 16.4 ft/sec^2 (0.51 x accel. of gravity). In Test 90, the vehicle had an impact velocity of 33.9 mph and rolled off the posts with a final velocity of 25.7 mph. As in the previous tests, the average deceleration was computed during the period the car was in contact with the posts and indicated the test vehicle slowed at 15.1 ft/sec^2 (0.47 x accel. of gravity ie. 0.47 "g").

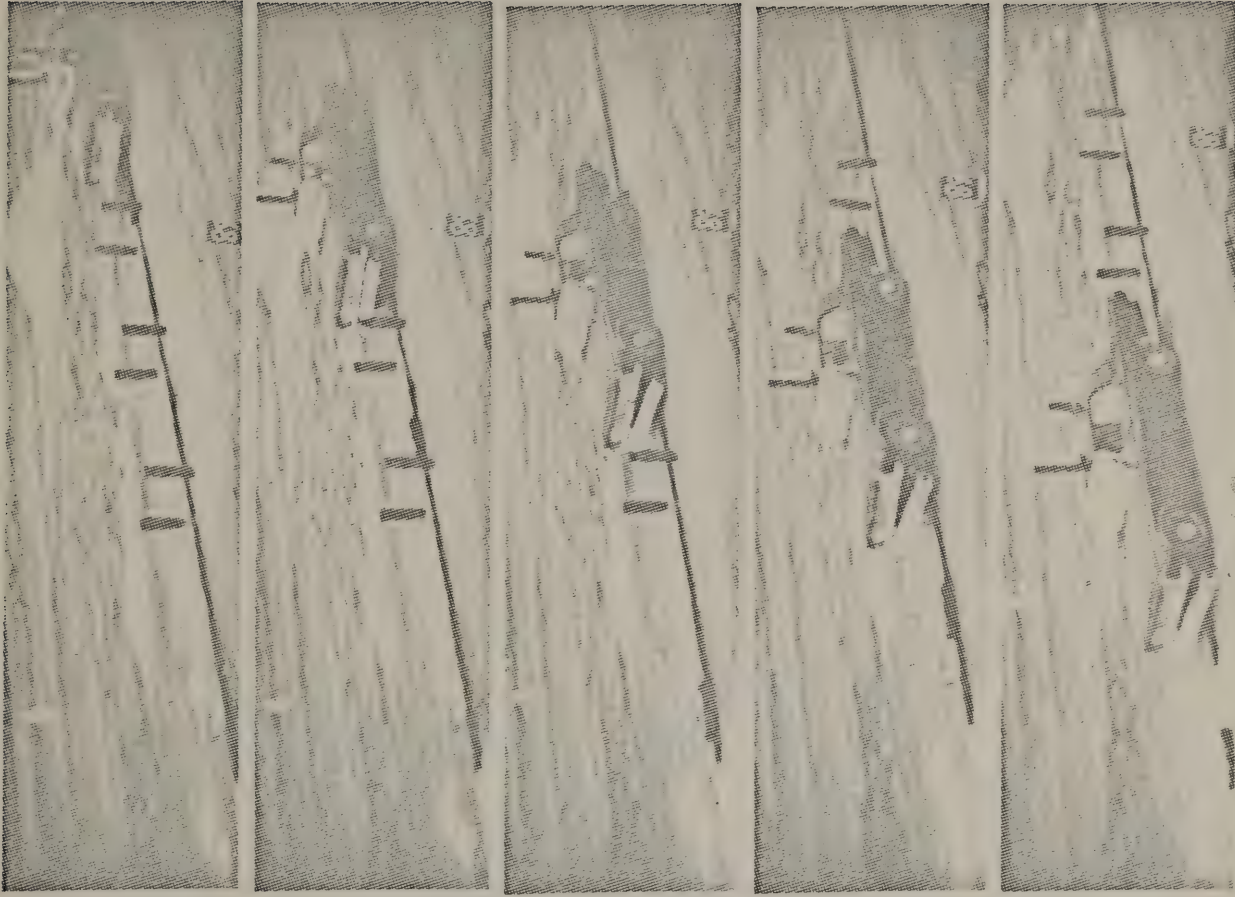
TEST 89 SUMMARY

Speed: 21 mph
Angle: 0° (head-on)

Speed: 0 mph
Angle: 0°

Length of Post-Vehicle Contact: 29.1 ft

Average Deceleration: 0.51g (1.900 sec)

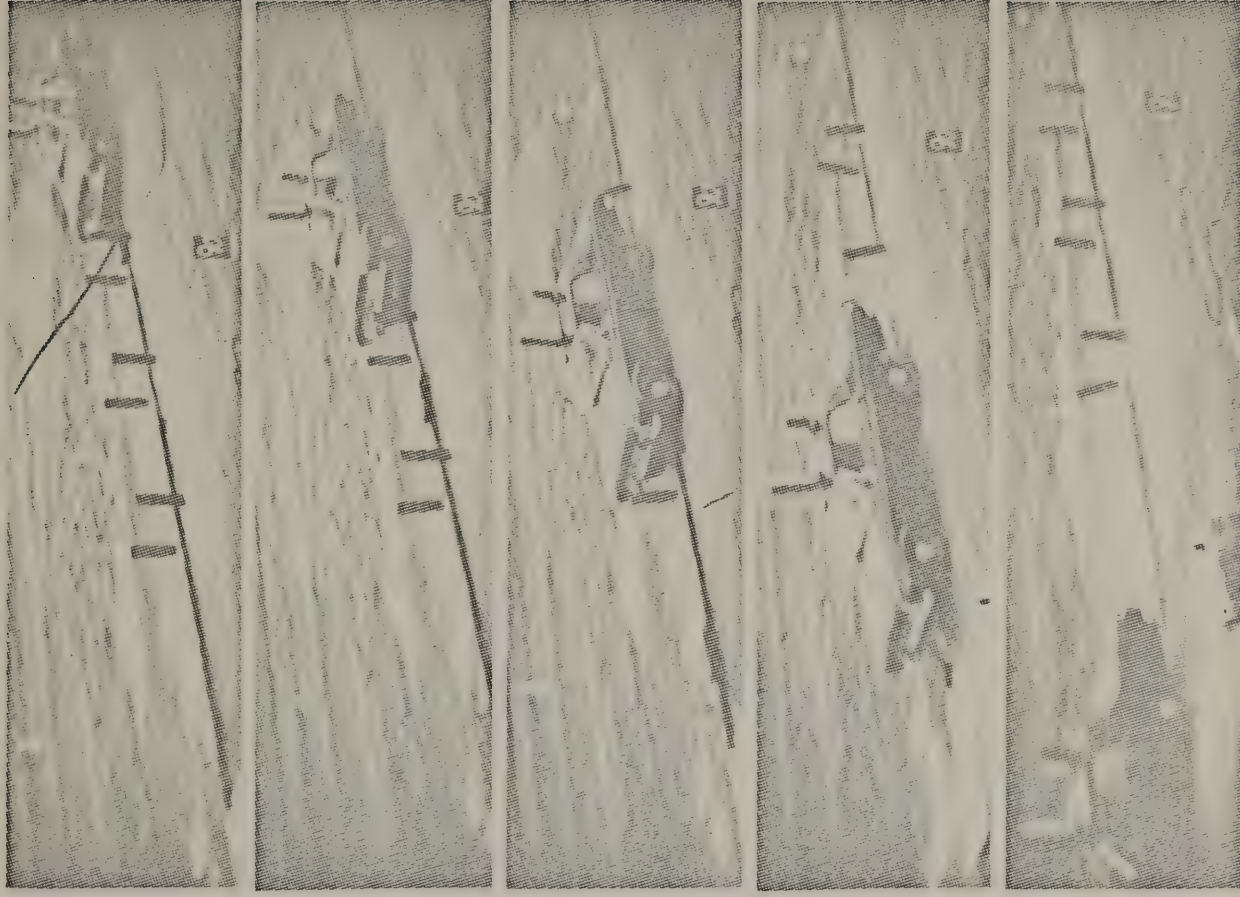
TEST 90 SUMMARY

Speed: 33.9 mph

Speed: 25.7 mph

Length of Post-Vehicle Contact: 36.4 ft

Avg. Deceleration: 0.47g (0.838 sec)

Vehicle's right front wheel off ground just before impacting Posts 5 and 6 (see third sequence shot). Vehicle brakes not applied during test.

In the photograph of the actual tests, it can be seen that in Test 89 and Test 90, there was a tendency for the front of the vehicle to rise as it hit the posts. In Test 90, it was noted that the right front wheel was off the ground. Had higher speed tests been performed the vehicle wheels might have been lifted from the pavement and loss of control might have occurred. It was decided not to perform tests at higher speeds because of
